DIAMONDYZE™

DiamonDyze was designed to improve both Type II and Type III anodizing. The goal was to improve the conversion of aluminum to aluminum oxide, add additional ceramic, improve the surface finish, improve wear resistance and improve corrosion resistance. DiamonDyze was designed to do so with minimal changes to the existing process, for both Types of anodizing. The goal was accomplished and requires only one simple step to implement the process into an existing line. *Add DiamonDyze to the Dye tank.*

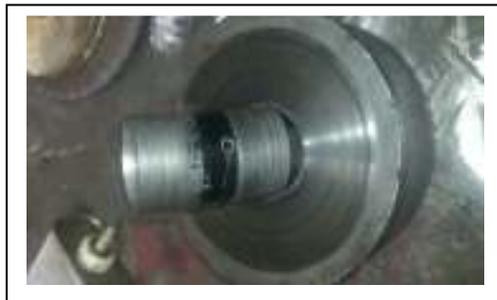
#2

Bruce ran a test on an aluminum bearing assembly. The client was seeing his aluminum bearing unit fail 3 or more times per year. This is a bearing that rides on a steel shaft with two steel wheels riding on the bearing. Below is a photo of the assembly *after 1 year of use*. The bearing was DiamonDyzed and the only change was the color being rubbed off (Color goes into the part after the DiamonDyze, so a major portion of it rides right at the surface). There was no wear to the part beyond the color, as can be seen below. The unit fully assembled is also shown as well as the disassembled bearing and hub.

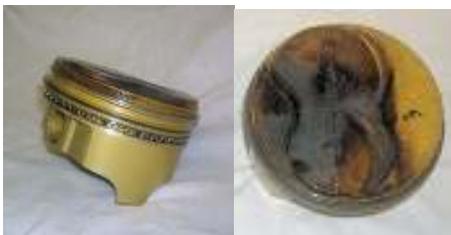
#3

The test engine was assembled with all DiamonDyzed Type II pistons and then put through two days of Dyno testing. No special machining was performed. The engine was a 350 Cu In Chevrolet normally making 350 H.P.

No evidence of galling or wear at all. The pistons, other than the slight carbon present and mild color changes at the top, looked like they had not been run.

The cylinder walls and cross hatch actually looked better than when The engine would not detonate. The spark plugs showed no distress using hot plugs.
